open issues

AGIPD 1.0 meeting 01.04.14

Test on single chip assembly performed at P10 12/13.1.14

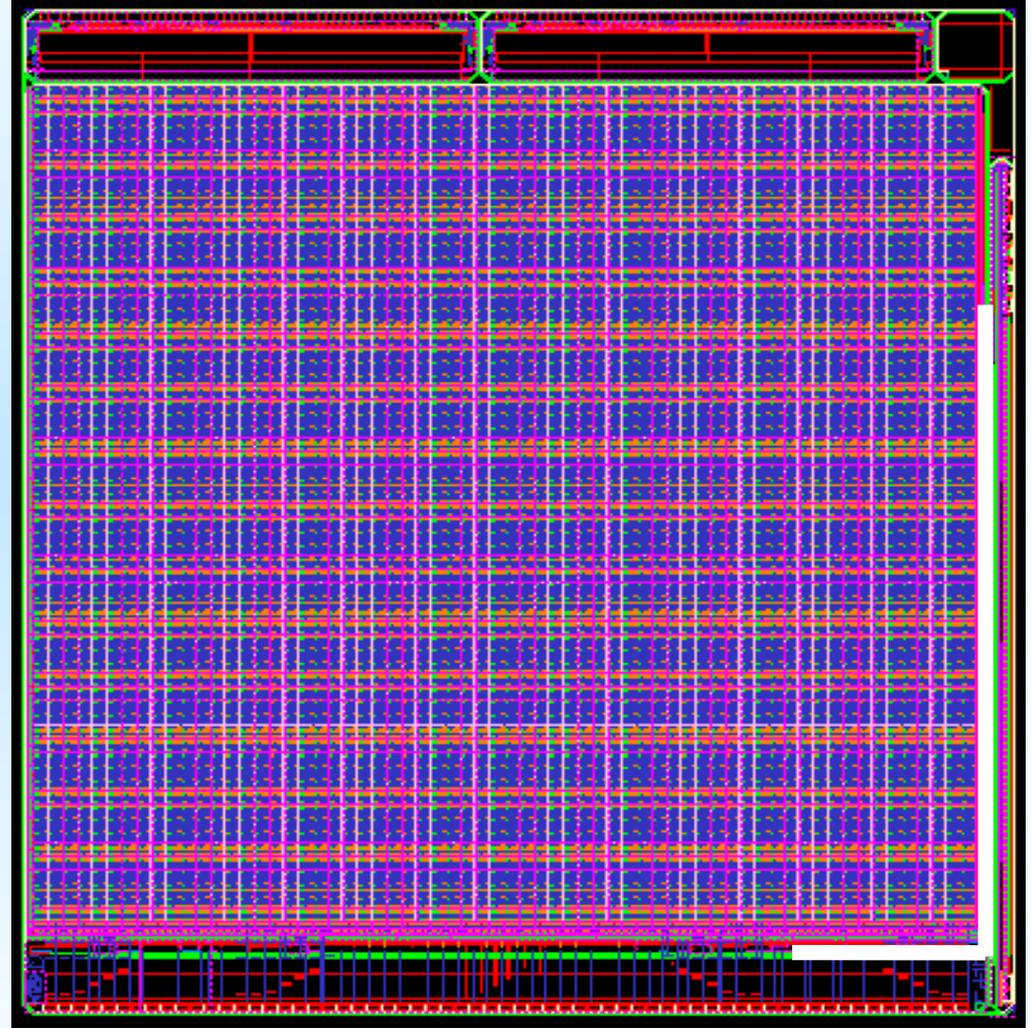
open issues: output delays

observed: output signals coming from different "quarters" of the chip have different delays.

Slowest ones need a readout rate slower than expected

attributed to: capacitance of the (long) lines is too big for the colbuffer to drive them in the expected times

several possible fixes have been identified

- 1) reduce capacitance load of lines by resizing them. This would be the cheaper (1 mask respin) but the least effective solution
- 2) increase driving power of colbuf
- 3) relocate mux (shorten path of fast signals)

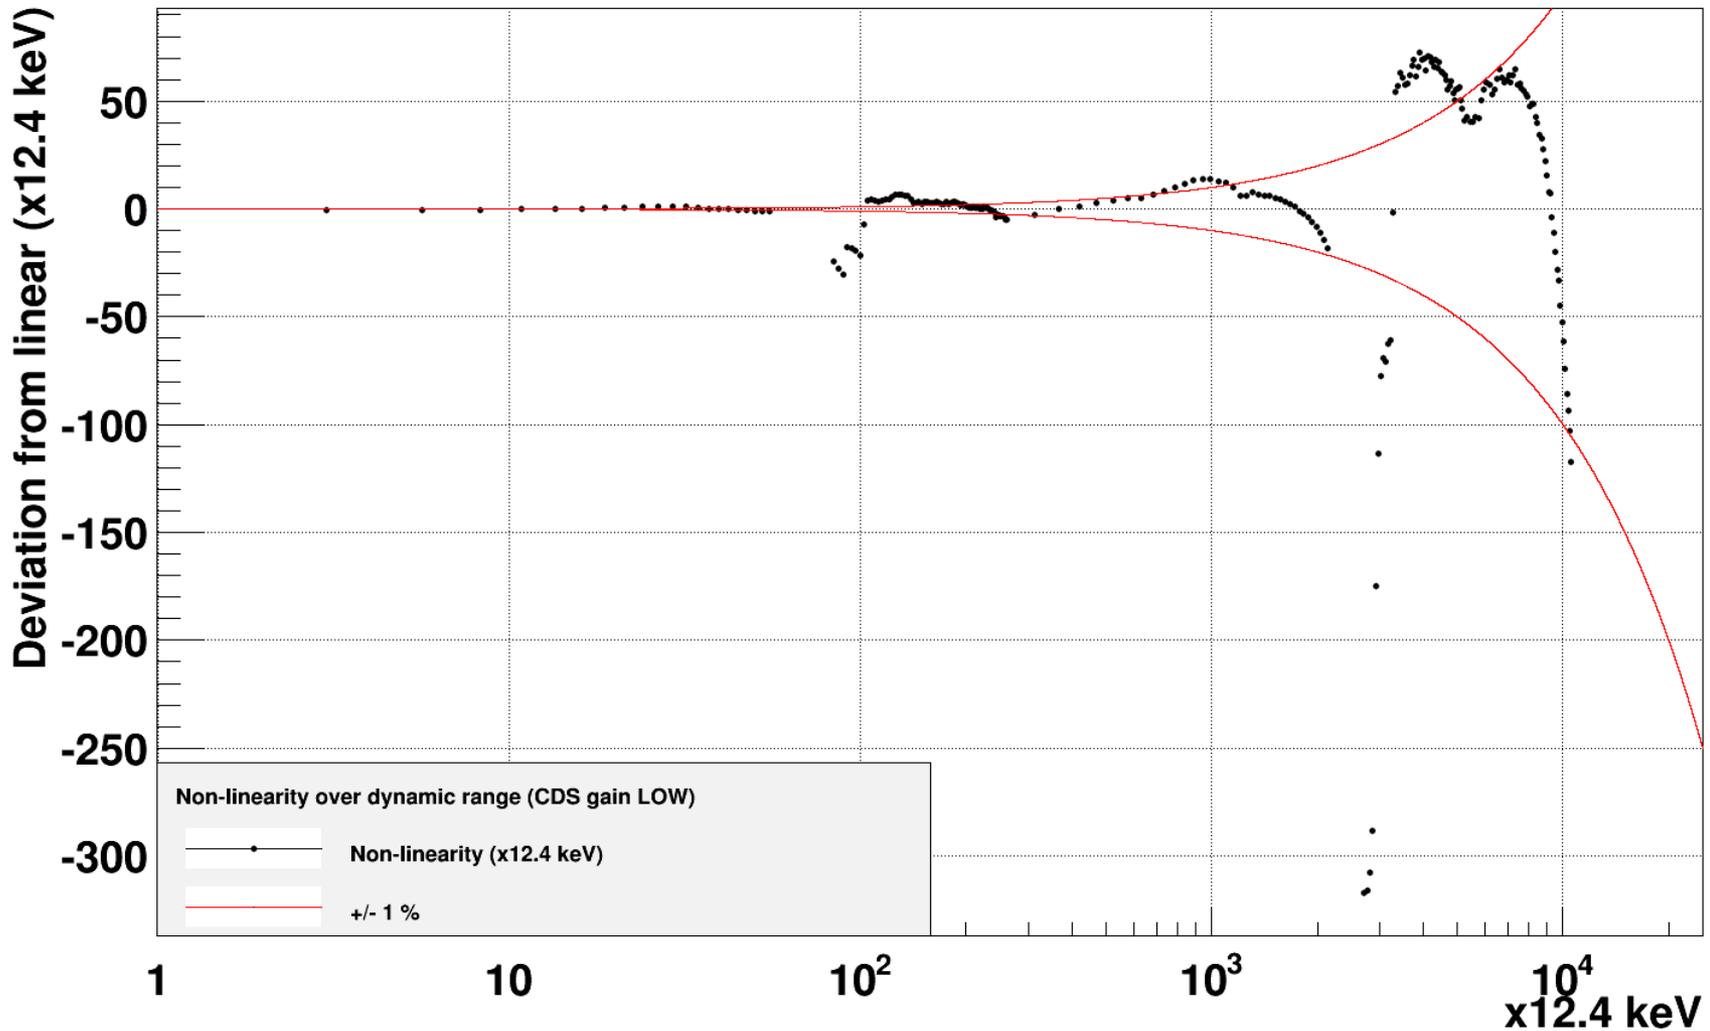
AGIPD1.0 - Chip 1 - Deviation from linear (x12.4 keV) - Bulb

deviation from linearity

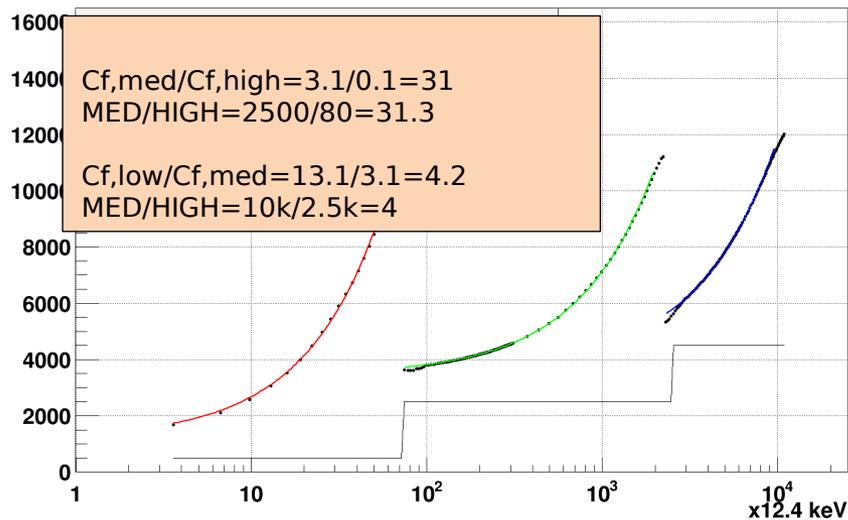
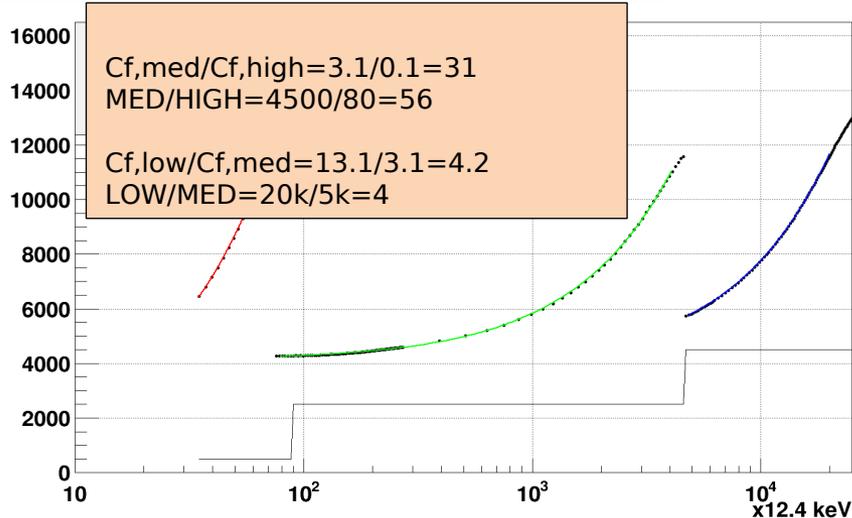
AGIPD1.0 - Chip 1 - Dynamic Range by TEST CURRENT - (Internal Biasing, Chip clock: 40 MHz, CDS gain LOW)

it remains to be seen if the current source (as is now) can be used for calibration

There seems to be an anomalous current variation between high and medium gain.

The current erogated by the current source is the same between medium and low gain, but it is different between high and medium gain.

The variation observed is roughly by a factor of 2; simulations predict a variation much less relevant than that

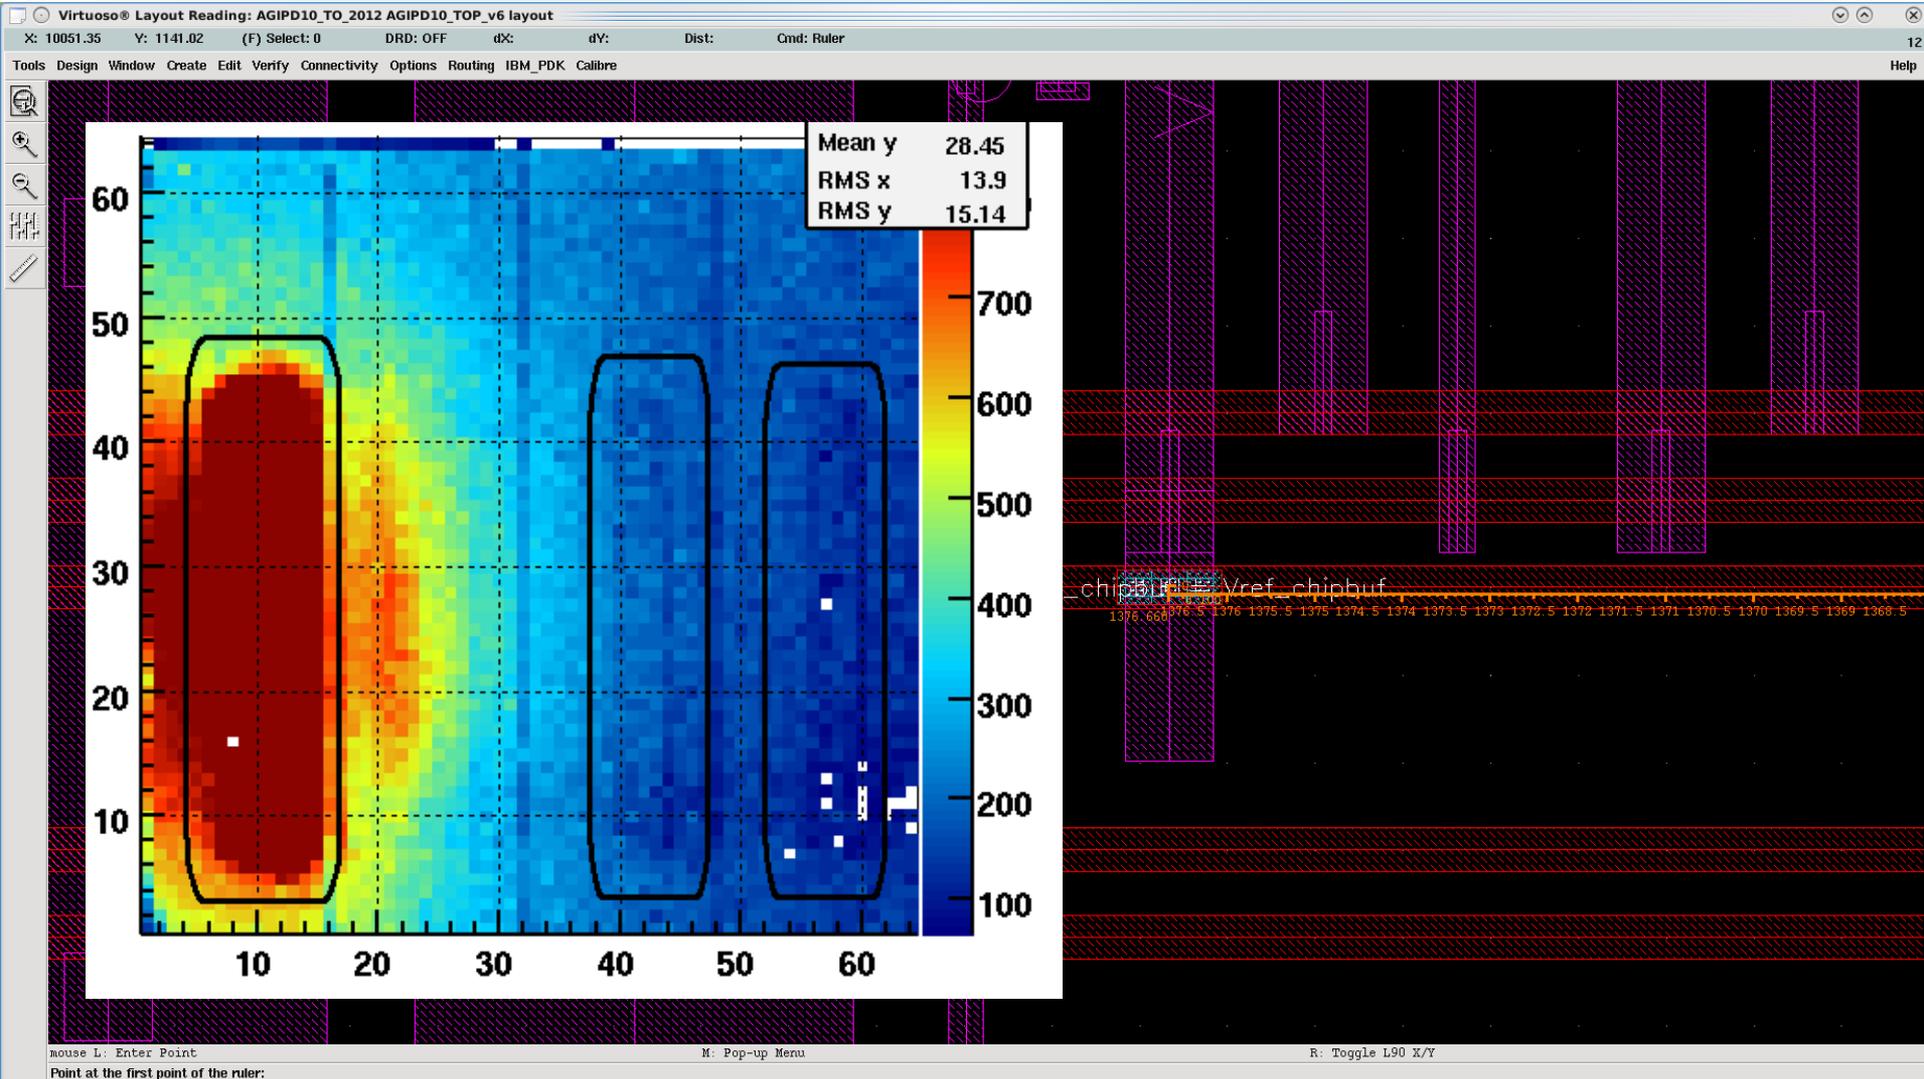
Cross talk between outputs

attributed to: voltage drop on Vref_chipbuf distribution
Not pure voltage bias: substantial current is pulled when the output varies → voltage drop (line resistance) → voltage seen by circuits connected to the line changes. solveable by:
1) larger distribution line
2) better: introducing a buffer stage near the circuit to be biased, to eliminate current-induced voltage drop
