*Status of Sensors:*

## **Sensors and bump-bonding**

Jianguo Zhang

*Deutsches Elektronen-Synchrotron (DESY)*

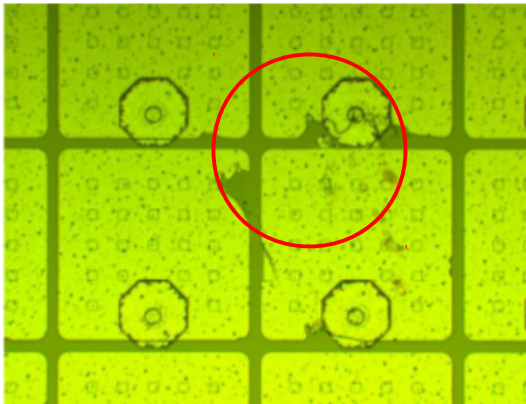
- Issues observed in UBM & bump deposition processes (by Dectris):
    - metal adhesion
    - scratches
    - particles on/inside passivation
- } → influence on imaging quality

metal layer problem

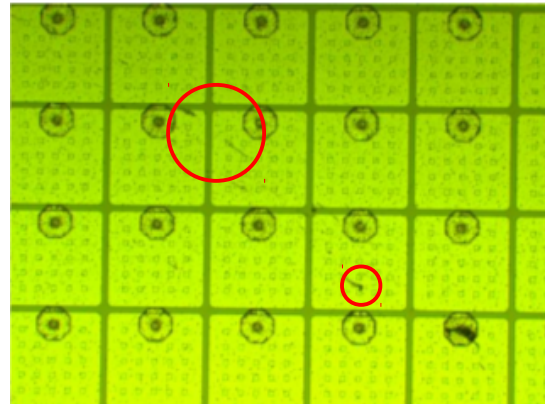
scratches

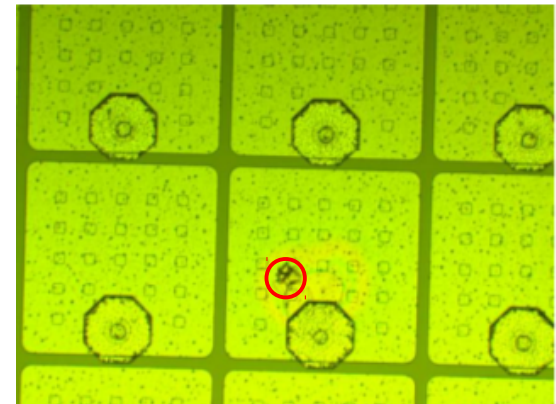
particles

Similar observations through visual inspection at UHH!

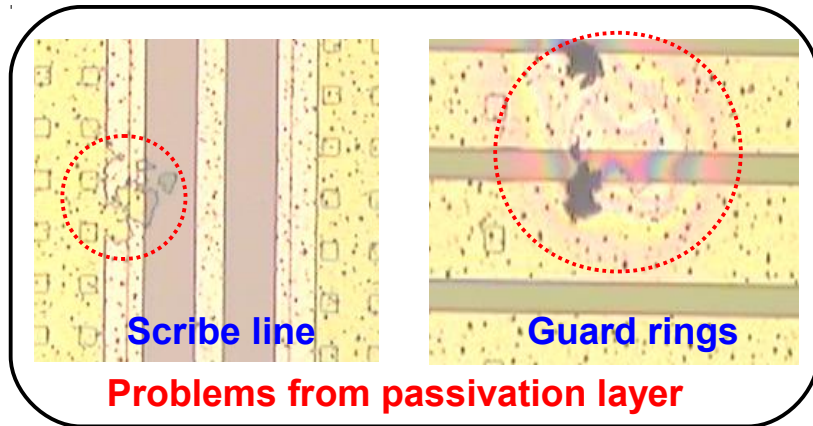
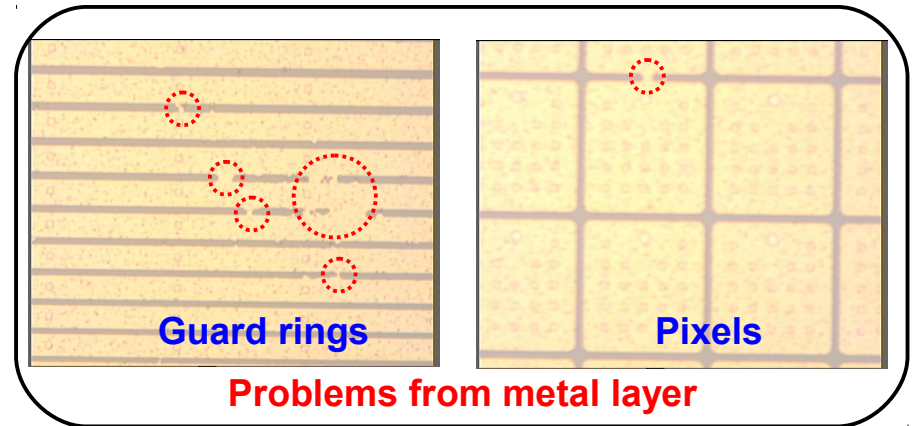
- Visual inspection for pixels and guard-ring structure of ~ 10 wafers
  - problems observed for passivation and metalisation

- Judged as bad sensor by Sintef from I-V measurement; actual problems observed through visual inspection at HH
- Information stored (12k images/sensor) → “trace back” in case problem

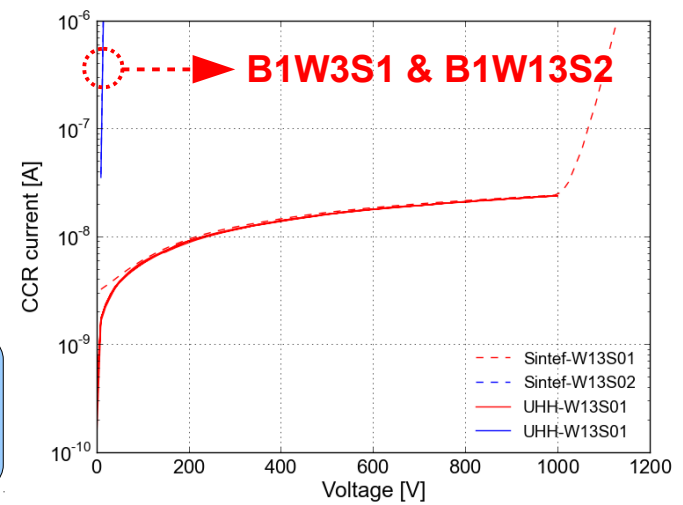
**Metal adhesion:**

- in GRs: early breakdown (2 sensors)
- in pixels: loss spatial resolution (2/65536 pixels)

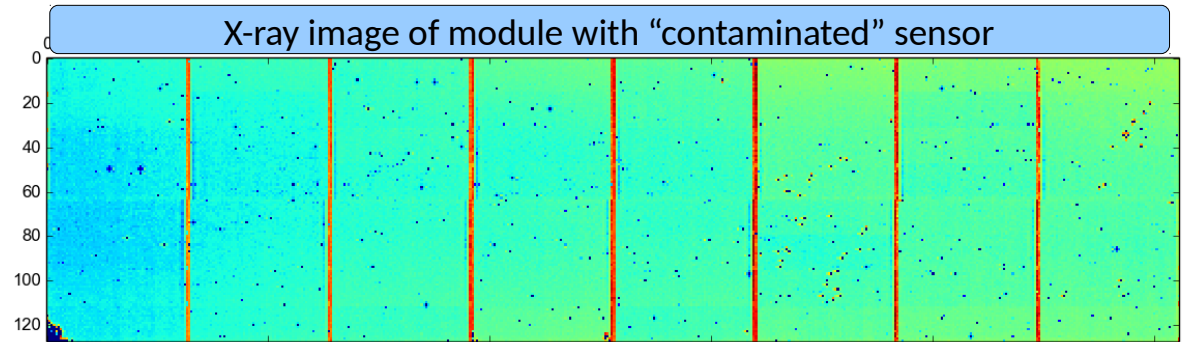
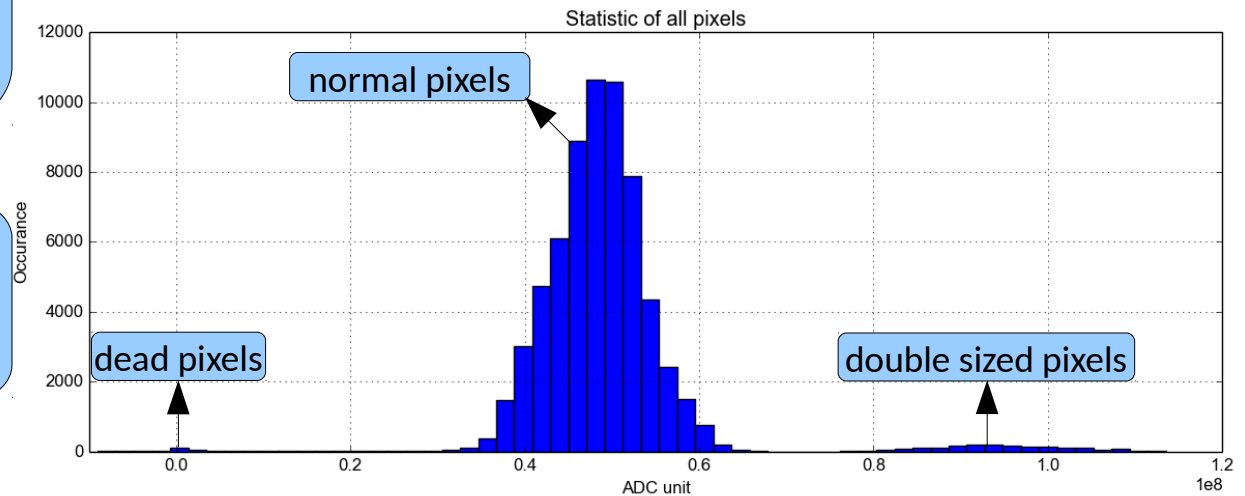
~ 0.6% bad pixels (estimate):

- <0.1% from ASICs
- ~0.2% from unbonded bumps:
  - \* 0.08% due to bonding
  - \* 0.12% due to size of indium ball
- ~0.3% from sensor:
  - \* <0.2% hot pixel
  - \* others

- metal adhesion: 1
- scratch: 0
- **particles: ~ 604**

“Contaminated” sensor (more sticky particles)! → check other modules!

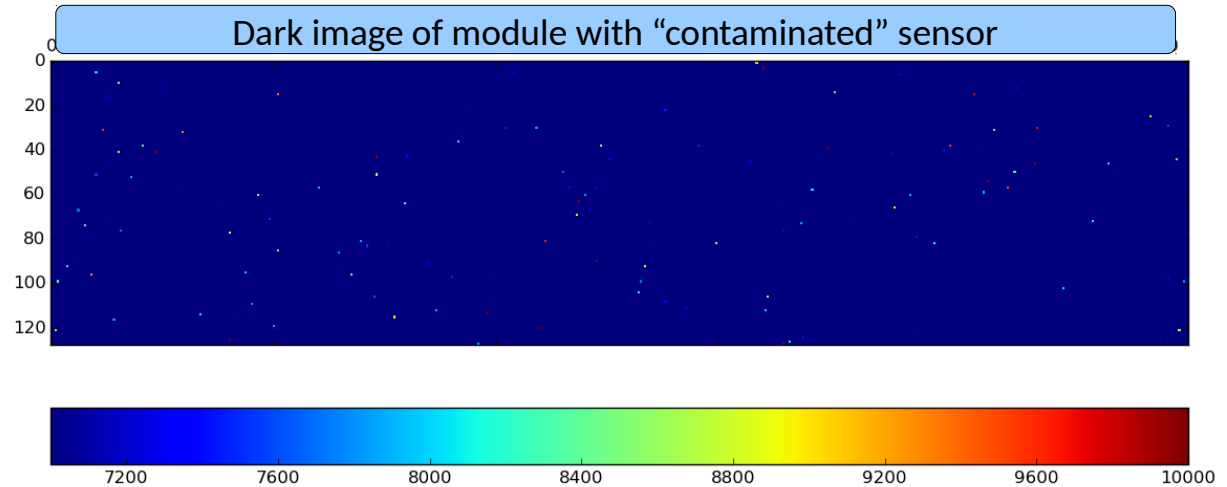
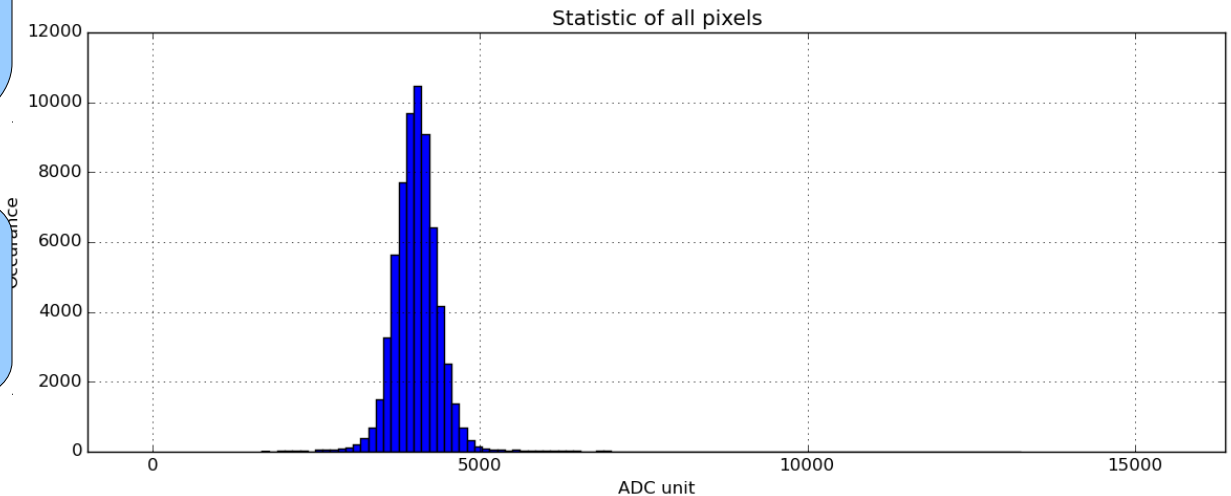
~ 0.6% bad pixels (estimate):

- <0.1% from ASICs
- ~0.2% from unbonded bumps:
  - \* 0.08% due to bonding
  - \* 0.12% due to size of indium ball
- ~0.3% from sensor:
  - \* <0.2% hot pixel
  - \* others

- metal adhesion: 1
- scratch: 0
- **particles: ~ 604**

“Contaminated” sensor (more sticky particles)! → check other modules!

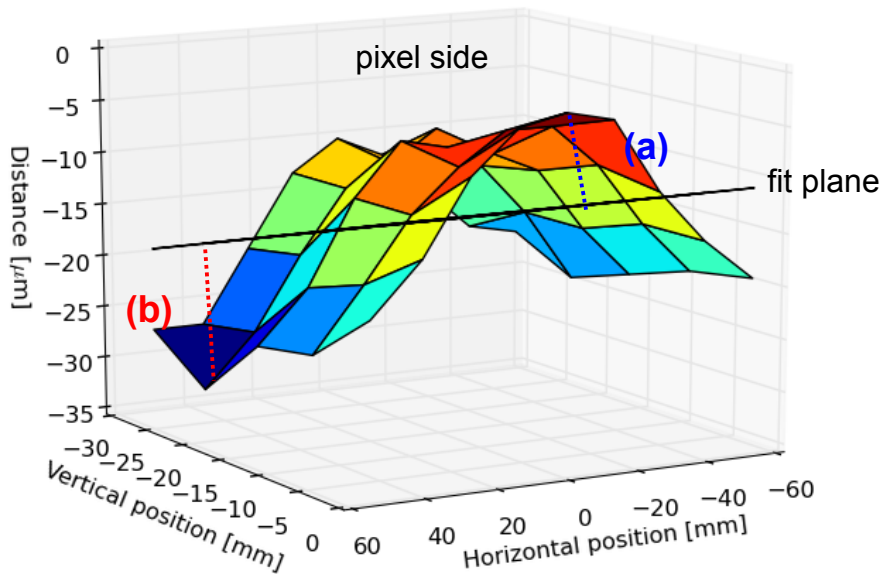
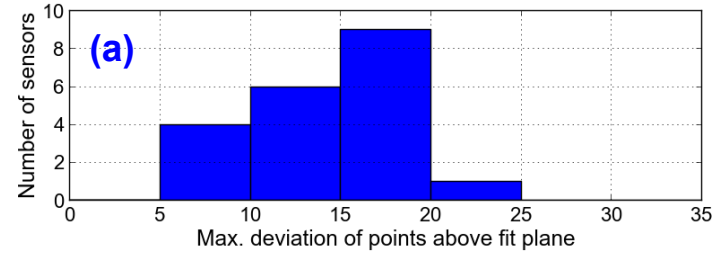
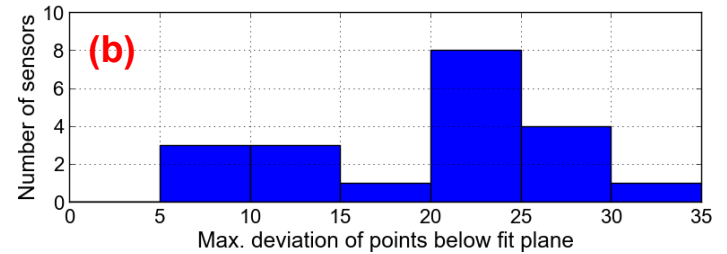
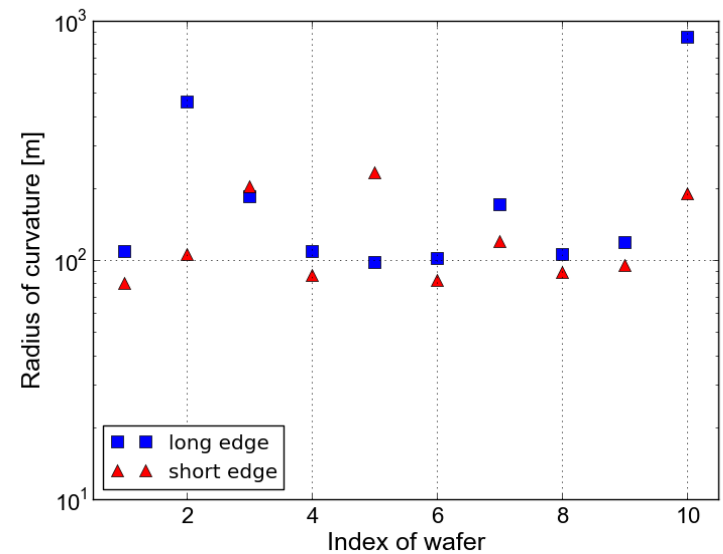
Measurement & Fit for Sensor-1

- Flatness measurement
  - fit to a plane for individual sensor:
  - radius of curvature:  $\sim 100$  m
  - max. force on a bond pad (0.01 – 0.1 mN)  
(bonding force: , de-bonding: )
